August 2, 2019

Re: Motion to Intervene (Out of Time) in Docket No. CP15-554-000 Atlantic Coast Pipeline

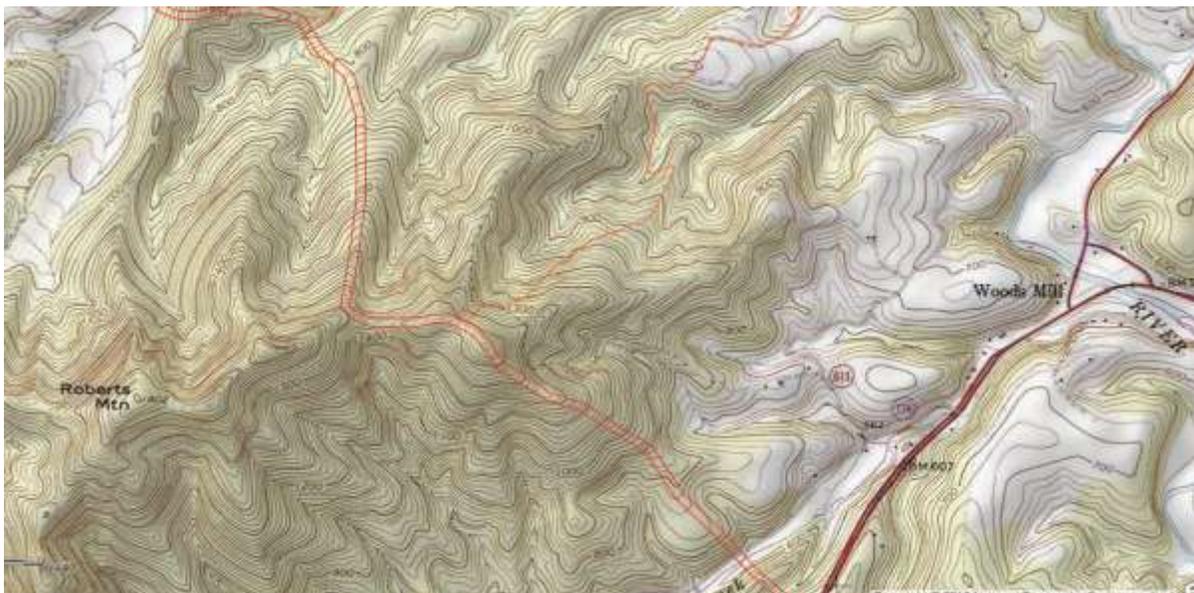
Figure 1: Roberts Mountain. Double red line is proposed ACP Corridor; single red line is proposed access road. The route crosses Davis Creek at bottom center. (Map courtesy of the Dominion Pipeline Monitoring Coalition).

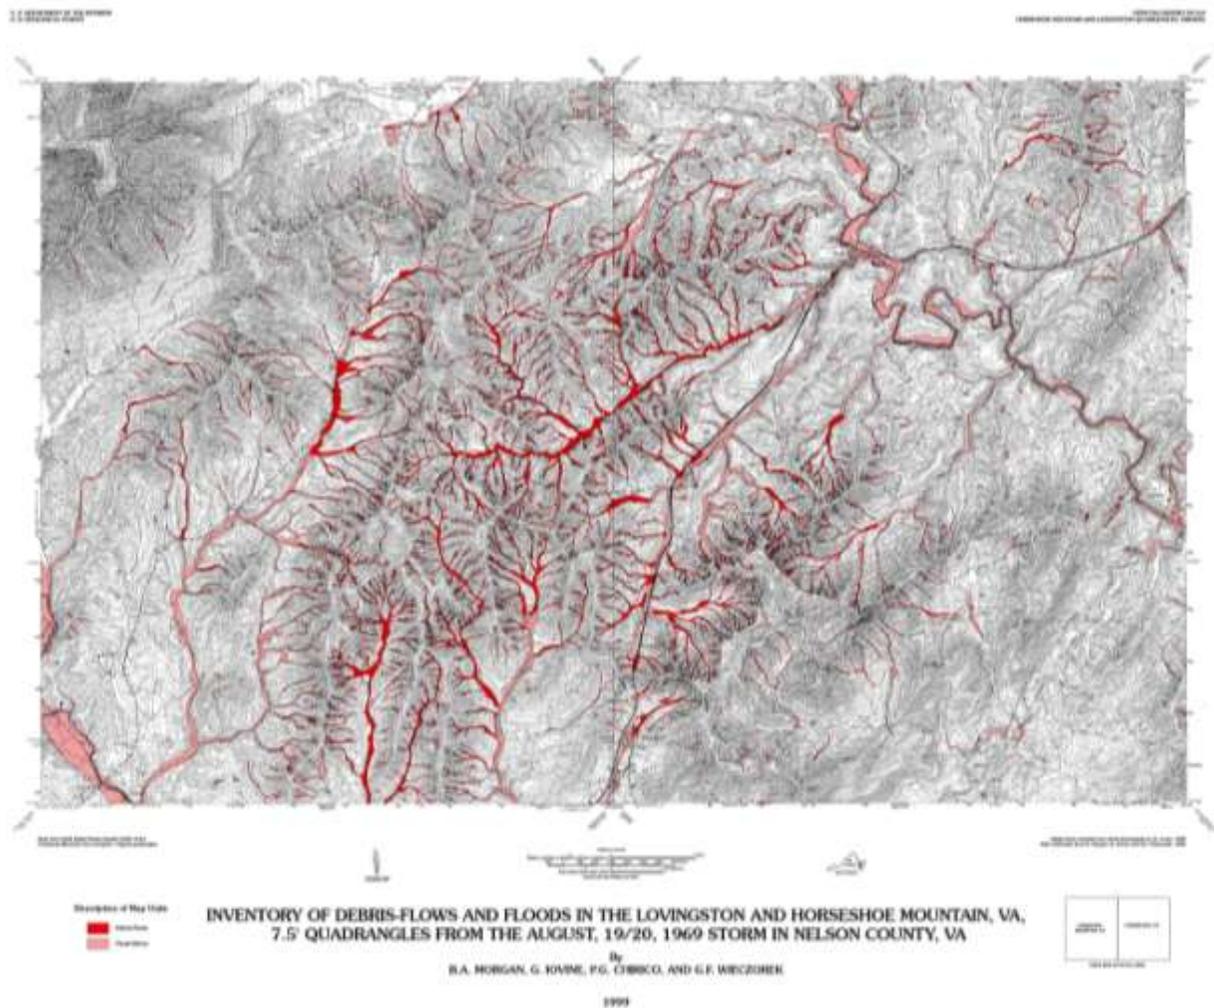
Subsequent to the event, the US Geological Survey conducted a study of the resulting slides, debris flows, and floods in Nelson County and created the following map charting their extent. This map (Figure 2)² is shown below in its entirety (the extent of the flow activity is shown in red).

Figure 2: USGS Debris Flows in Nelson County, VA due to Hurricane Camille

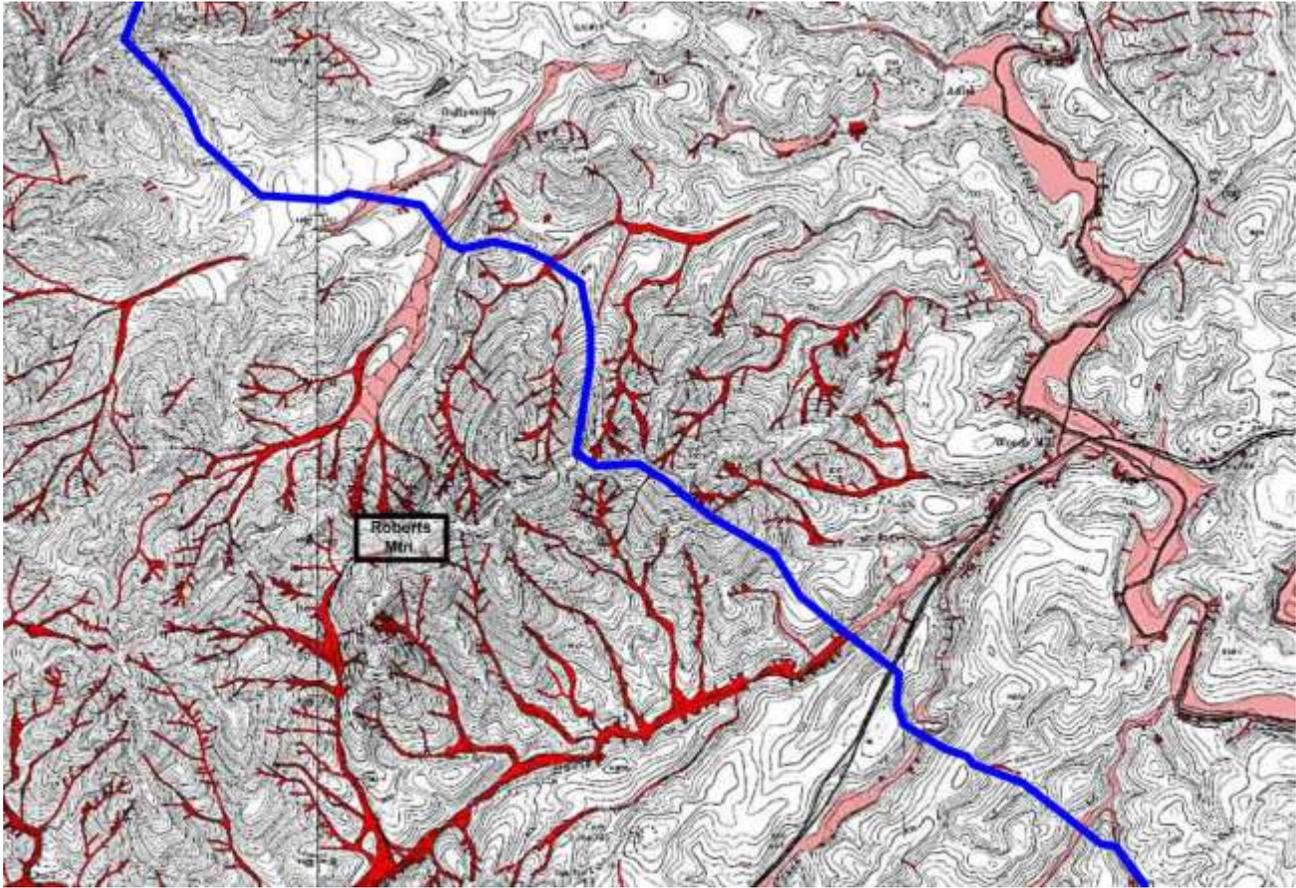
For clarity, Figure 3 shows an enlarged portion of the above image including Roberts Mountain and the lower portions of the Davis Creek watershed on which the ACP route has been superimposed (in blue).

Figure 3: Debris Flows associated with Roberts Mountain and immediate vicinity

Figure 6: Soil slippage events in Nelson County, VA as revealed by DMME LIDAR study. (The ACP route is overlaid in red and the area focused on in Figure 3 is outlined in blue.)

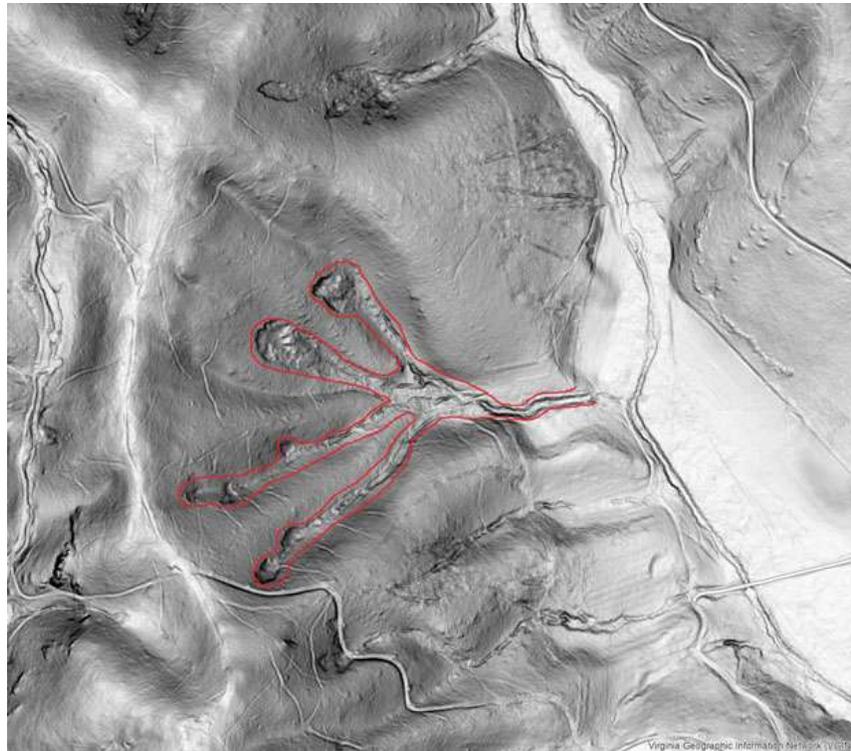
Figure 4: Landslide features are outlined in red in this LiDAR-derived slope-shade basemap. These features are at Fortune’s Cove in Nelson County, Virginia.

The following representative images of a neighboring area in the cluster of mountains immediately to the south of Roberts Mountain give an idea of the potential for LiDAR technology to shed additional light on the results of the 1969 event.

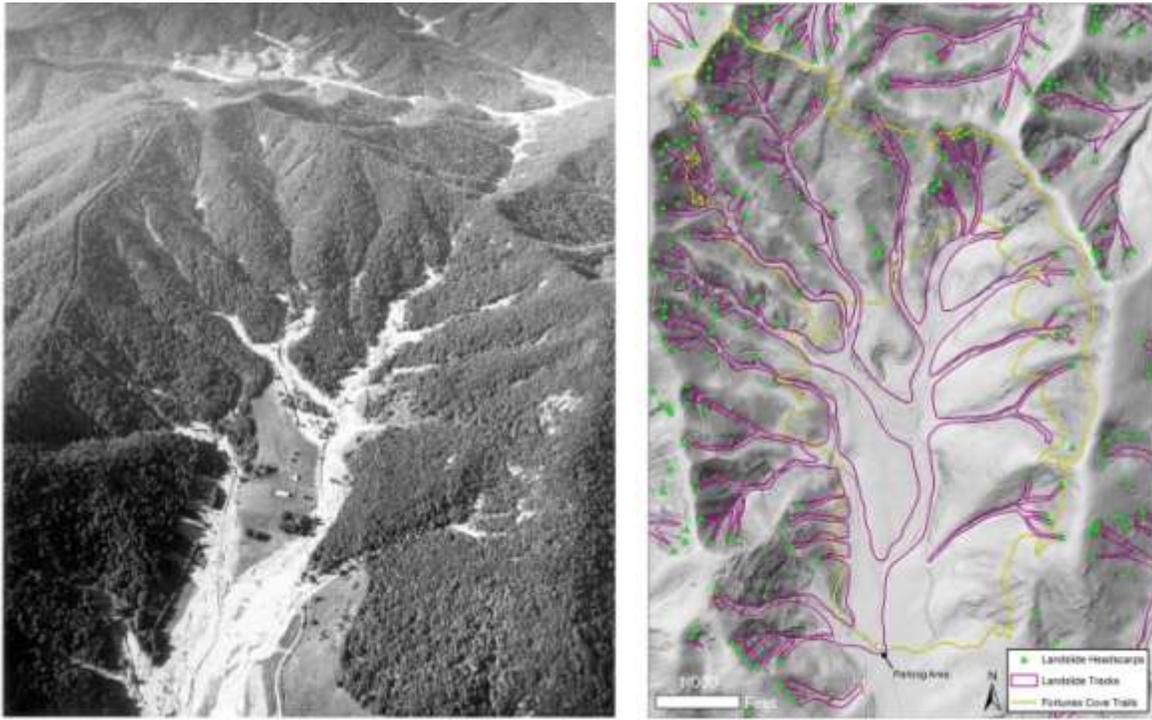
Figure 5: Left: An aerial view of Fortune's Cove taken days after Hurricane Camille. View to the north. Right: Landslide features in Fortune's Cove, as they appear on the 2016 LiDAR basemap.¹²

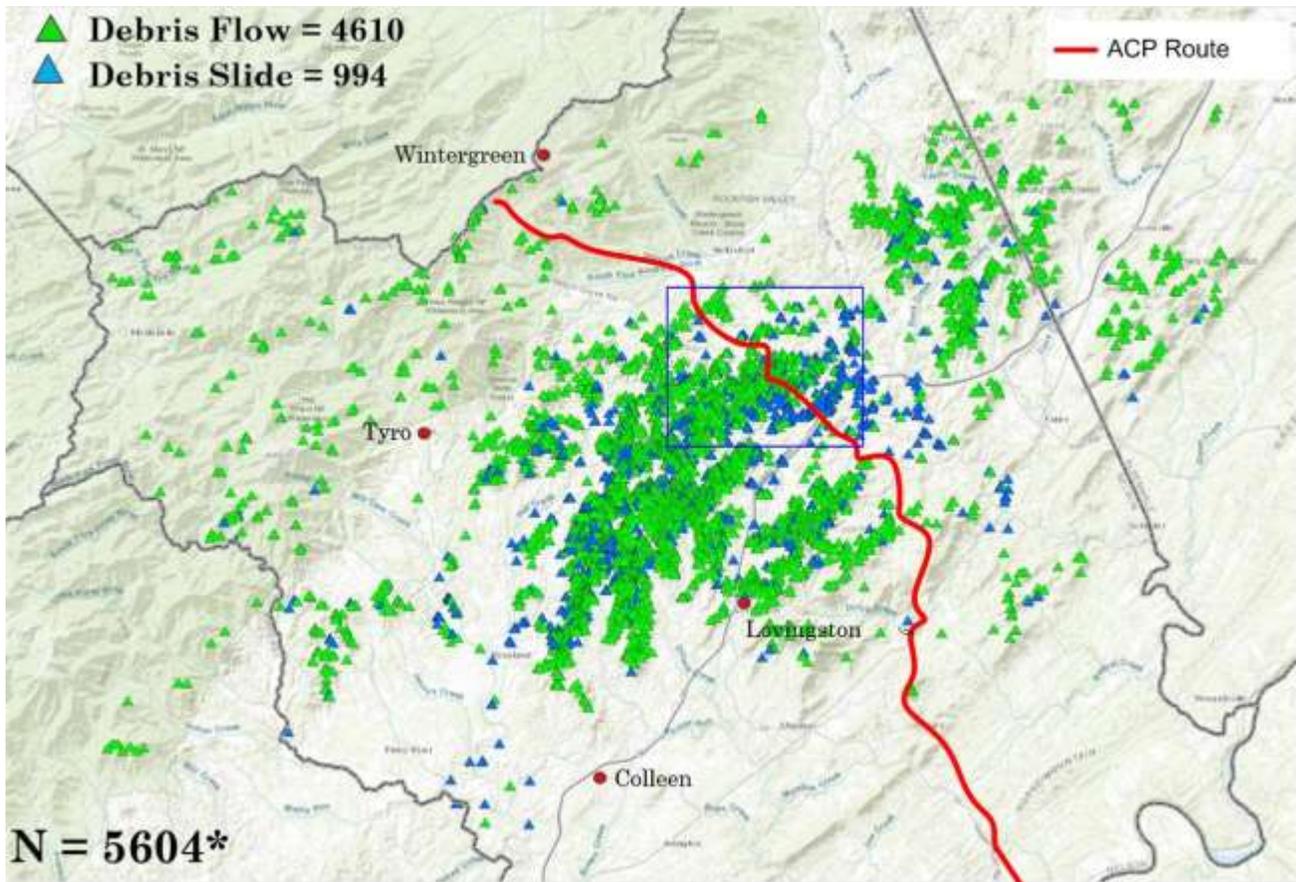
The following map summarizes what the study has found so far in terms of the sheer number and extent of soil slippage during the 1969 event, and illustrates the number that occurred on, or immediately adjacent to the current ACP route.

Clearly, these new data render the claim made in the FEIS, that “Atlantic incorporated a route alternative (the East of Lovingsston Major Route Alternative) to avoid the debris flows and other features identified by the USGS”, substantially less accurate (and potentially more misleading) than previously thought, and in fact, function to reinforce the already convincing evidence summarized above that the conclusions of the EIS are flawed, and that rather than avoiding them, the current route cuts directly through some of the areas of highest density of debris slides and flows. In fact, as shown in Figure 5 above, these features are revealed to be not only more numerous, but *frequently located much closer to the ridgelines along which the pipeline is typically slated to be routed than has been previously been apparent.*
